Erosion and sediment yield from a landing failure after a moderate rainstorm, Tairua Forest

A.J. Pearce and P.D. Hodgkiss

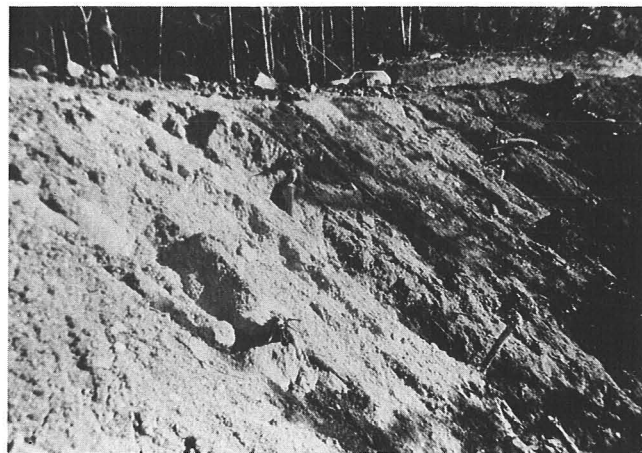
Figure 1 Eroded landing fill edge shortly after April 1983 storm. Figure indicates depth of gulying in coarse uncompacted fill.

As a result of the April 1983 storm, the northern edge of the fill forming the larger landing (on the south boundary of the 23 ha catchment) was seriously eroded in two places by both gullying and mass failure. At these places the fill was more than 10 m thick and was poorly compacted. The fill slope was often steeper than 40°.

was particularly thick in the head of a drainage depression, between 180 and 260 m³ of fill was eroded by mass failure and gullying (Fig. 1). Immediately downslope of the fill edge, the eroded material transformed into a debris flow. Considerable volumes of water from both the landing surface and a 70 m-long segment of road draining onto the landing must have mixed with the eroded debris to form the debris flow, because slopes below the landing are not particularly steep (20-25°). Gullying to depths of 1.5-2.0 m occurred in the fill along at least 30 m of the landing edge, confirming that large volumes of water flowed over this part of the fill edge.

The amounts of erosion and sedimentation caused by the April 1983 storm are excessive for the magnitude of the storm. If every storm of such size caused similar damage, then road and landing-related erosion at Tairua Forest would be approaching extreme levels, and this is not generally so. Other factors must have been involved in the extent of damage to this particular road and landing. One probable factor is poor compaction of the fill material, combined with the great thickness of fill in this particular landing. Landing edges were built up to slopes that were too long, too steep, and barely stable. Low moisture content of the fill, caused by the extended dry period during and before construction, probably made the fill difficult to compact properly. Water runoff from 70 m of road leading down onto the landing surface also contributed to the failure by providing additional water to that from the large (4000 m²) landing surface itself. Spillover of the surface runoff from the landing and road onto the very steep fill edges was the primary cause of gullyng, and, eventually, saturation of the fill edge caused mass failure.

7. Avoiding hazardous sites, or modifying construction and harvesting techniques to reduce the impact of fill failures if such sites cannot be avoided, are the keys to minimizing the impacts of logging on sediment yield and water quality. When problem sites cannot be avoided, proper fill compaction and drainage of surface runoff away from thick fill edges are essential.

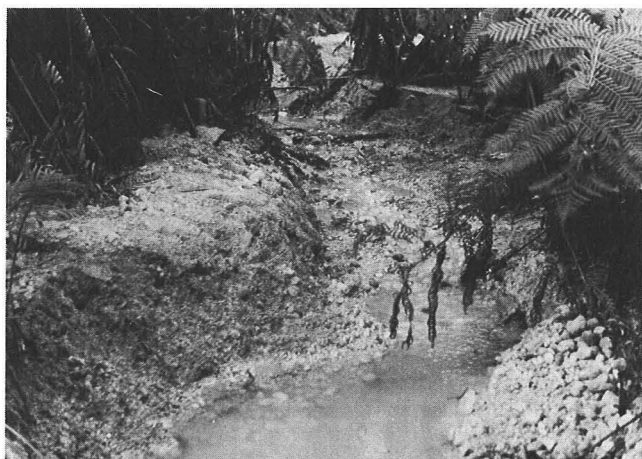
Figure 2 Sediment stored in small terraces on stream channel approximately 200 m downstream from landing failure.

At the point where the debris flow entered the stream, about 20 m³ of sediment was deposited in a pool in the stream channel. The largest boulder deposited here was about 70 cm x 50 cm x 40 cm, weighing about 225 kg. No deposits were found upstream of the point of entry. For about 350 m downstream of the entry point, as far as the monitoring weir, sediment had filled the channel to maximum depths of 60 cm, but much of this sediment was flushed out of the channel as streamflow fell after the rain ceased (Fig. 2). Narrow terraces about 20 cm wide and 10-50 cm high were formed along much of the channel. Between 40 and 80 m³ of fresh sediment were estimated to be stored in these terraces, and another 5 m³ within the stream channel immediately above the weir stilling pond.

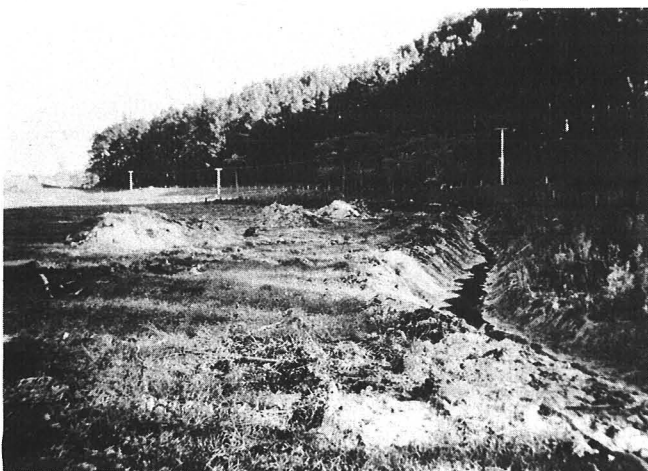
Figure 4 View of farm drainage channel and sediment excavated from channel 400-500 m downstream of landing failure.

blocked by sediment during the storm (Figs 3, 4). Deposition on pasture surrounding the blocked culvert was estimated to amount to a further 100 m³. Deposition in mangrove swamp in the tidal zone of Wharekawa Harbour at the mouth of the stream/drainage channel, some 500 m downstream of the landing failure, was estimated to be at least 15 m³. In total, the estimated volume of deposits was about 265-300 m³, accounting for most of the estimated volume eroded from the landing and hillslope. Of the total volume of deposits, at least 200 m³ was exported from the 23 ha catchment during and immediately after the storm.

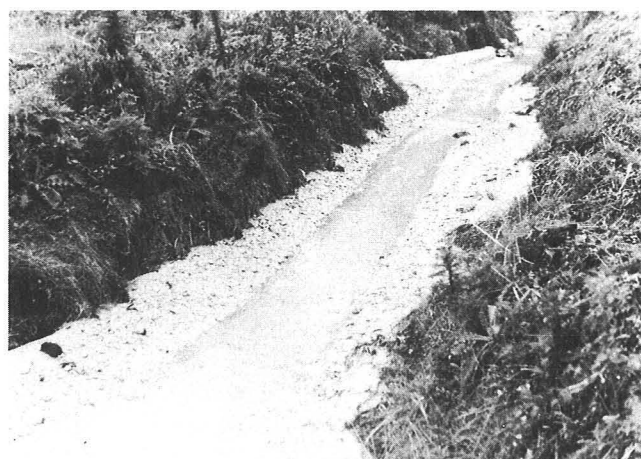
Figure 3 Sediment deposited in neighbouring farm's drainage channel approximately 400 m downstream of landing failure.

The stilling pond of the weir was completely filled during the storm, and 17 m³ of sediment were subsequently excavated. Below the weir the stream is culverted under Opoutere Road to flow across farmland in a drainage ditch. Some 70 m³ of sediment were estimated to have been stored in the drainage ditch upstream of a small culvert pipe which became
