Erosion risk, adverse weather events and catchment management

Assessing risk

Sally Strang

Environment Manager – Manulife Forest Management (NZ) Ltd
Chair NZFOA Environment Committee

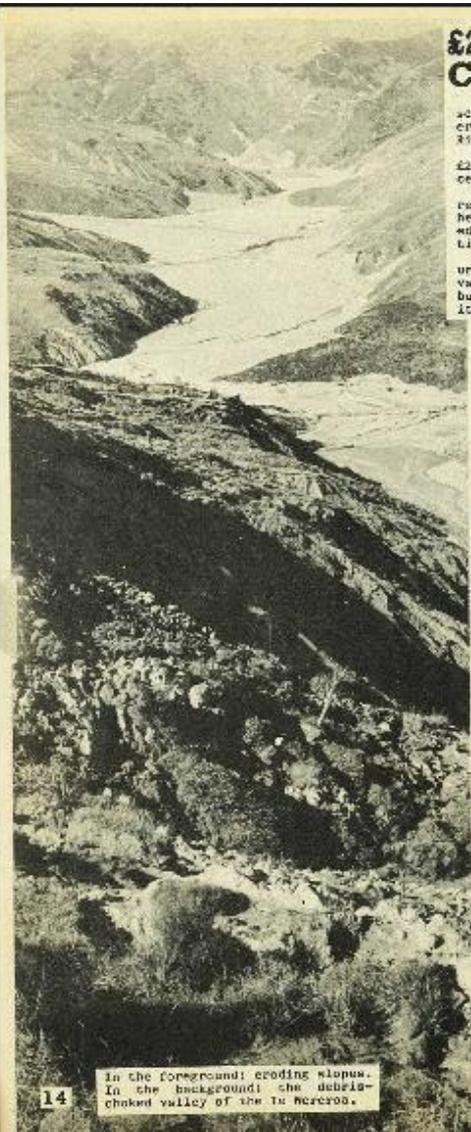
14

In the foreground: eroding slopes. In the background: the debris-choked valley of the Te Meroeroa.

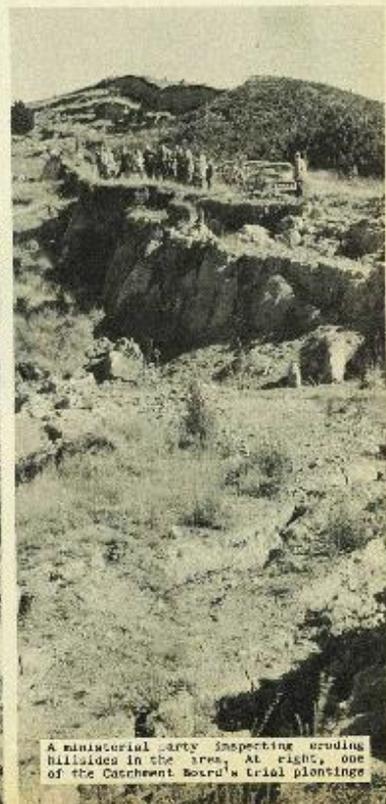
A ministerial party inspecting eroding hillsides in the area. At right, one of the Catchment Board's trial plantings.

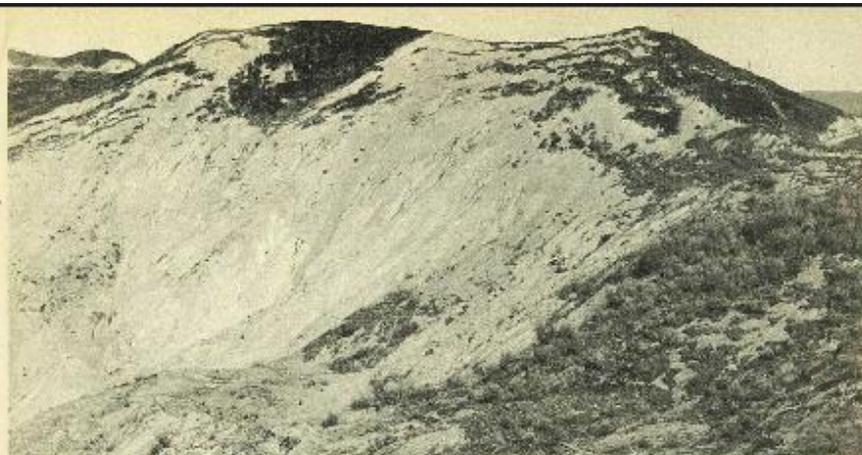
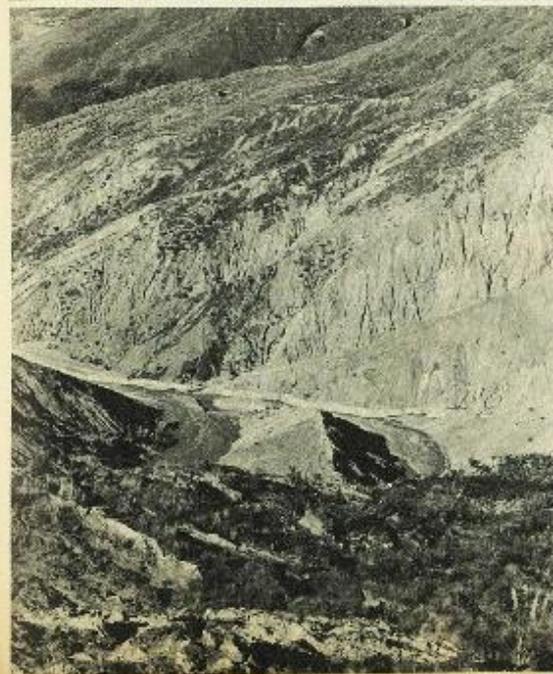
Above: An example of an eroded hillside adjacent to Turndale Road.

Left: A massive example of gully erosion in the crushed argillite area.

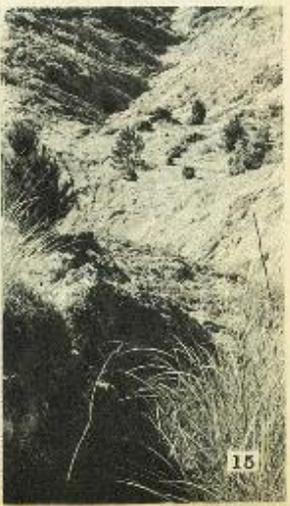
15

Below: Reforestation above this gully has checked erosion, encouraged growth of totus and other trees.

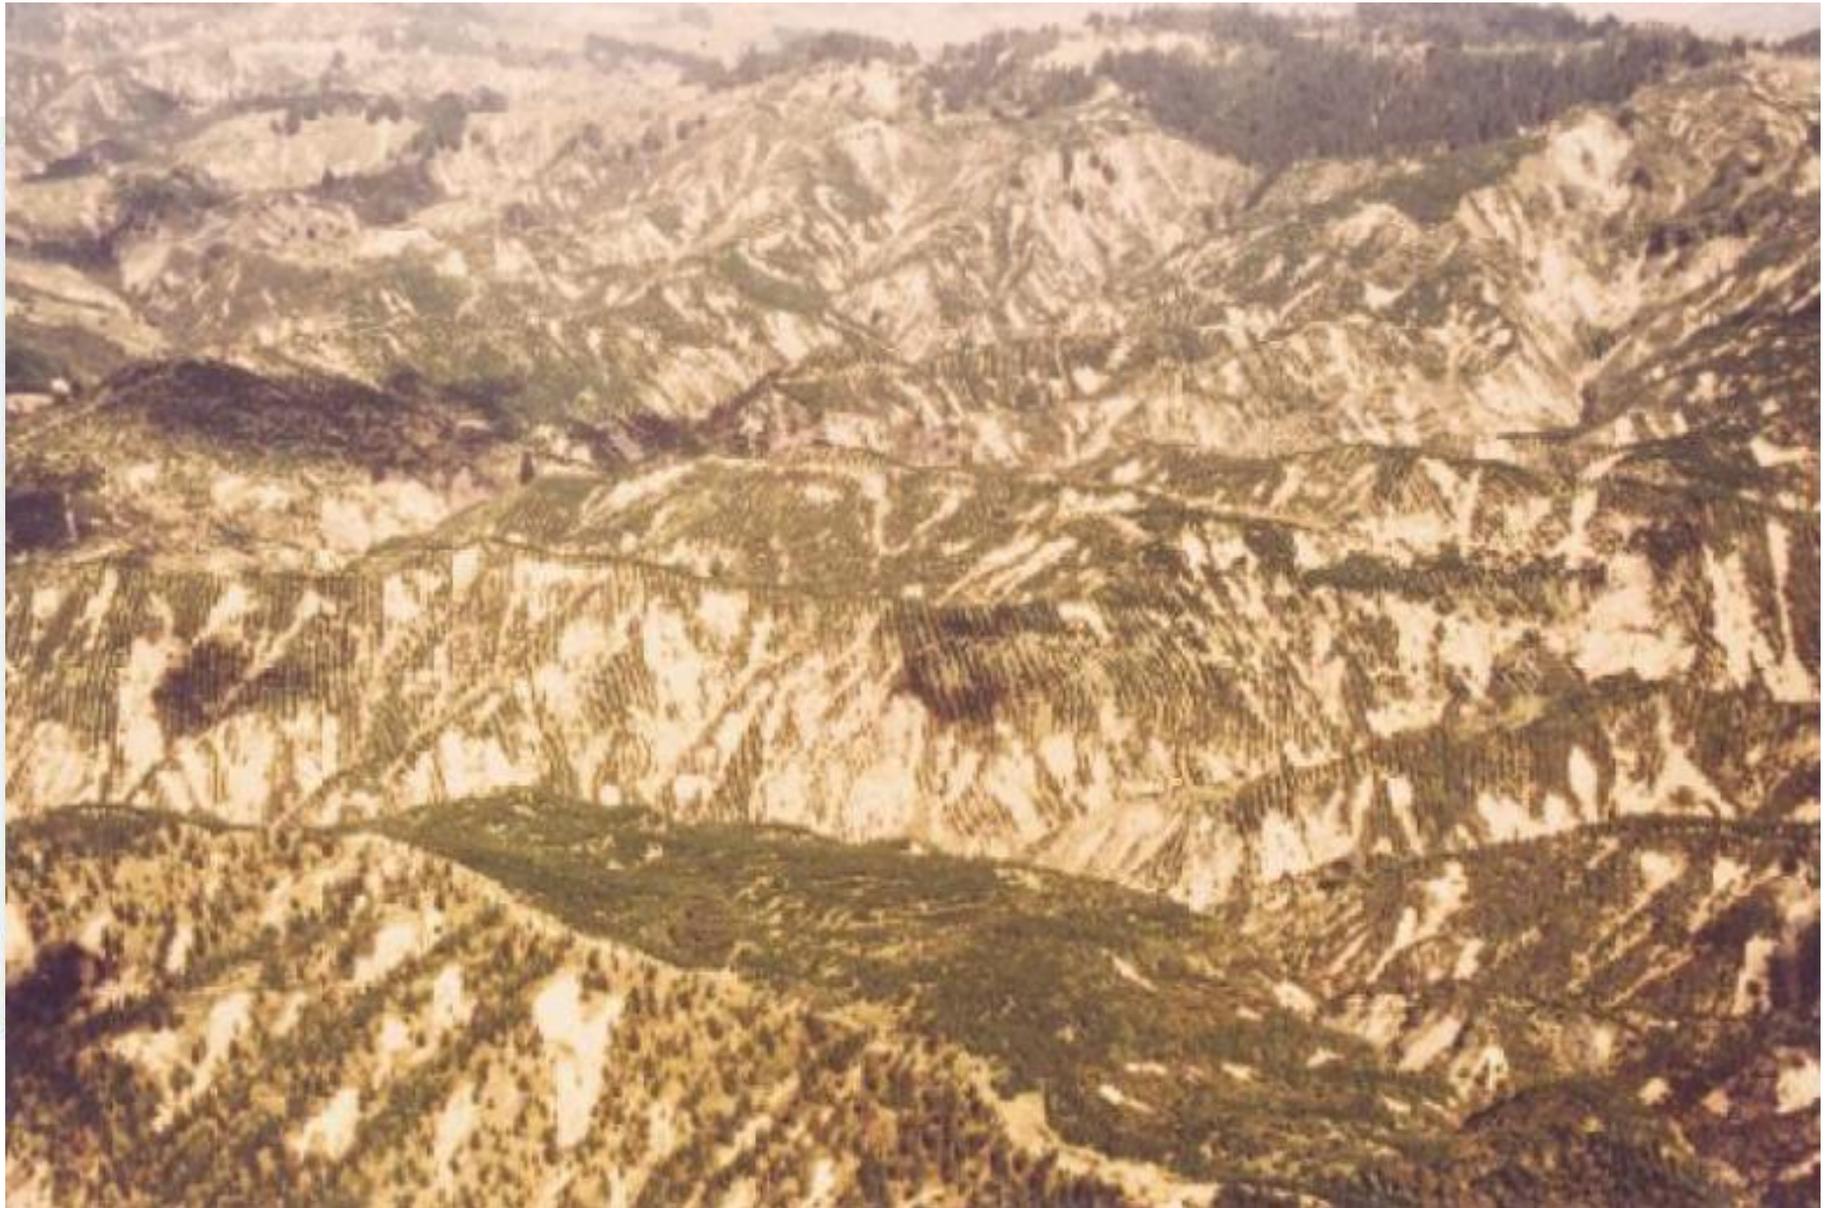
Cyclone Bola damage
Tolaga Bay

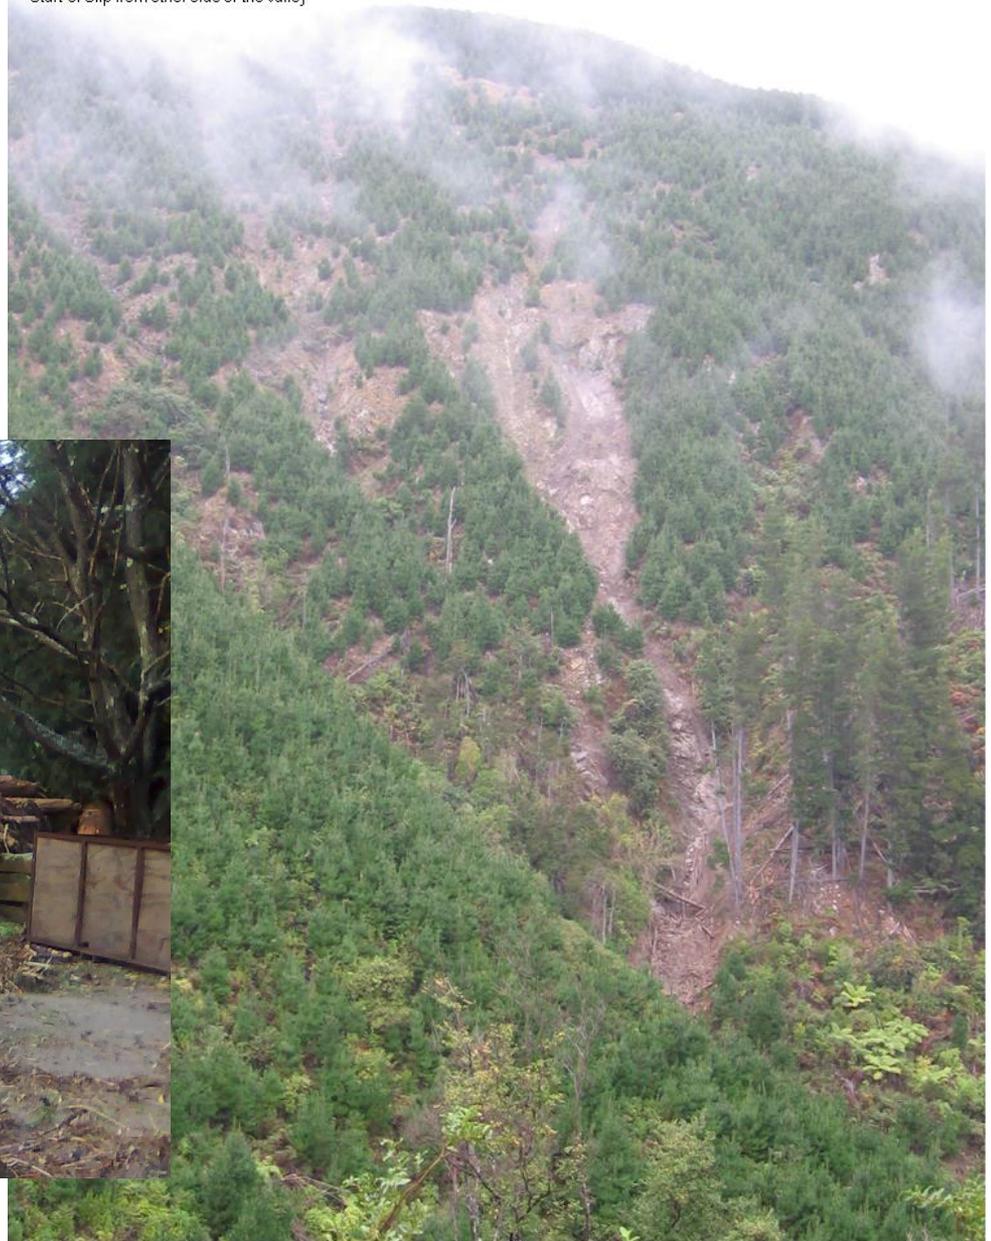
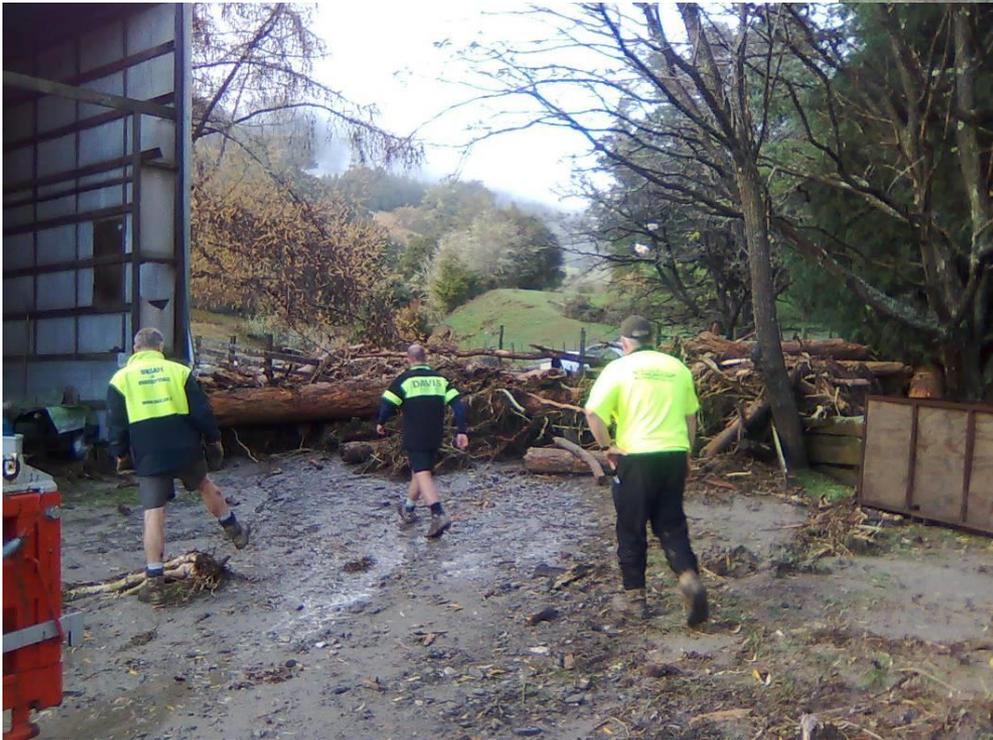
Start of Slip from other side of the valley

Eastern BOP April 2011 (280mm in 24hrs)

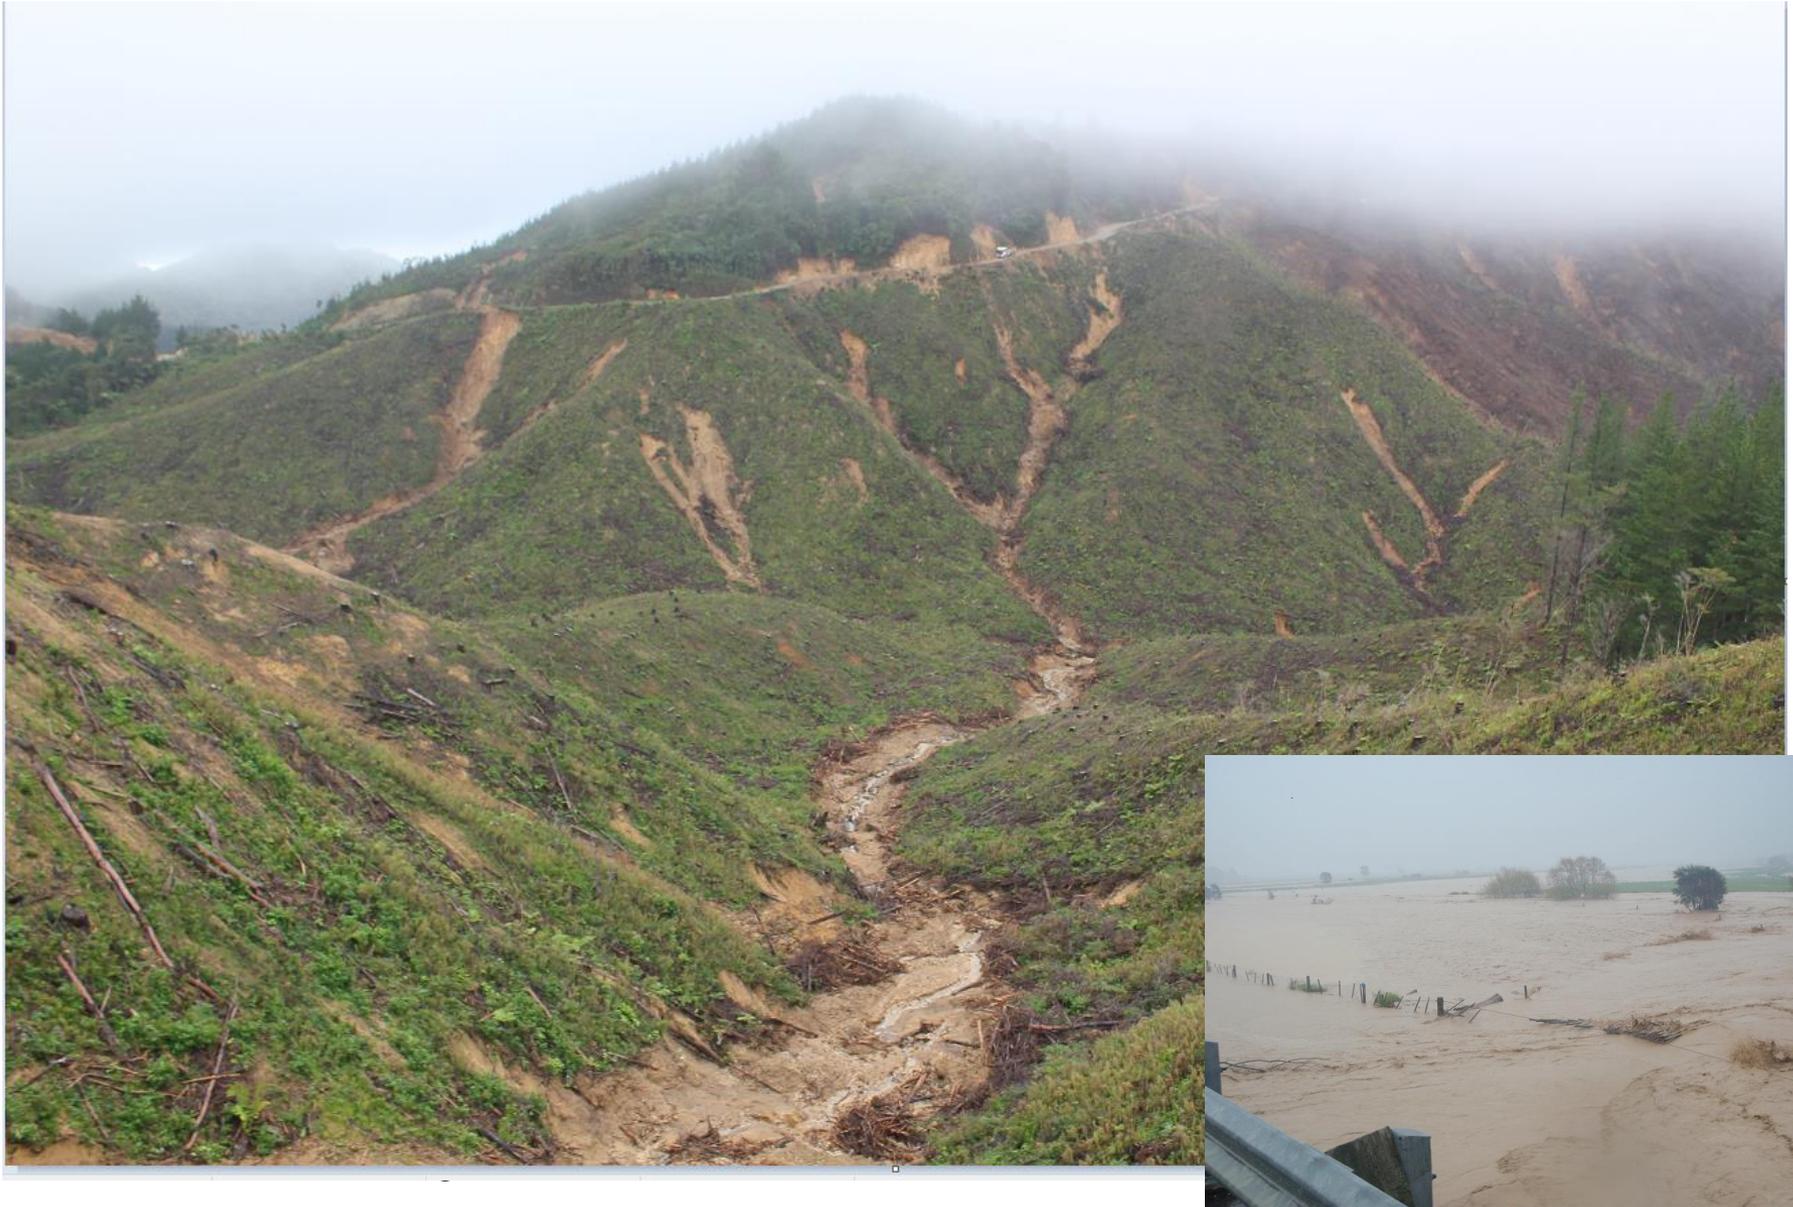
Taumarunui - Cyclone Cook April 2017

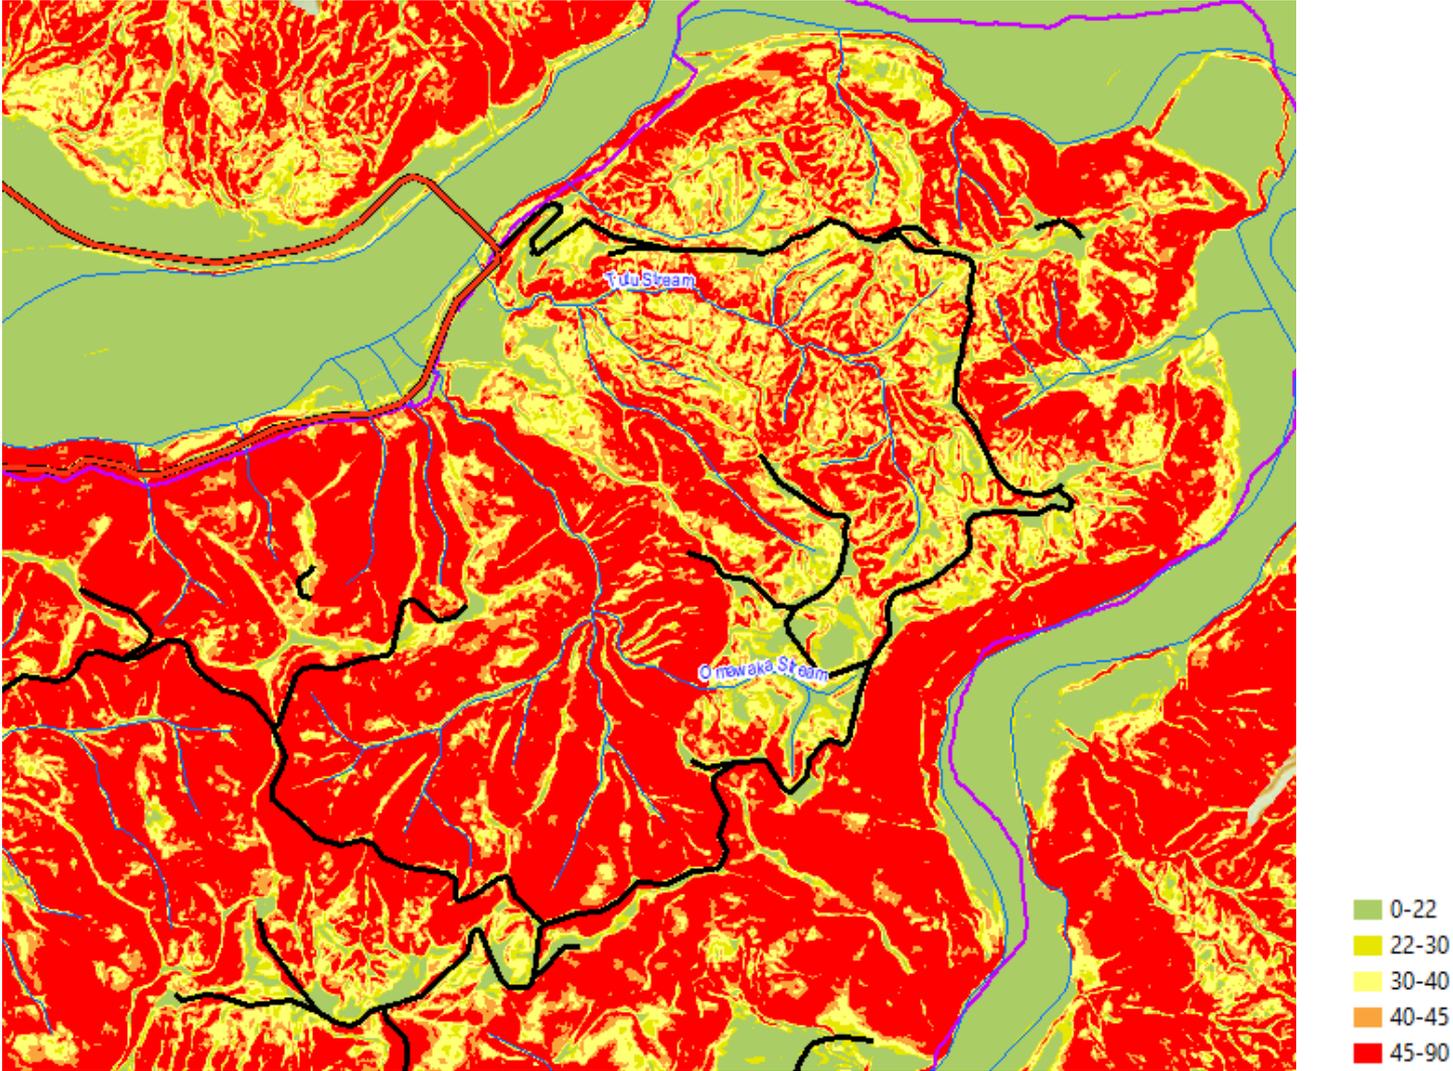
NES PF Erosion Susceptibility Classification (ESC)

Low Risk	Green Zone
Medium Risk	Yellow Zone
High Risk	Orange Zone
Very High Risk	Red Zone
