Forest harvesting in the Marlborough Sounds – Flying in the face of a storm?

Abstract

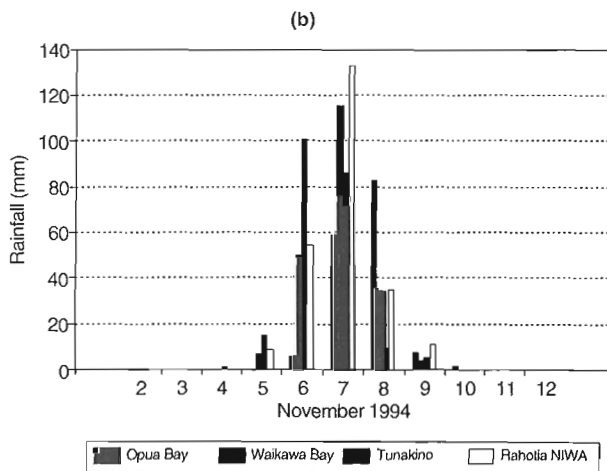
Figure 2. (b) Daily rainfall for November 1994 from four Marlborough Sounds rain gauges. (Note: all but Tunakino are located in Queen Charlotte Sound.)

The rainfall intensities of the November storm were not particularly high by local standards. Intensities of 200 mm in 12 hours are not uncommon for parts of the Sounds (Sutherland 1985) and these could be expected to occur once a year in places such as Nydia and Kaiuma Bays. However, there is generally a large variation of rainfall across the Sounds for any given rainstorm (Figure 2b).

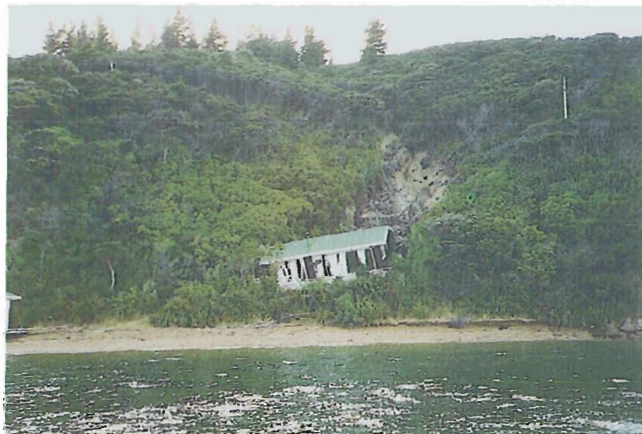
Figure 3. (a) Bach on east side of Blackwood Bay damaged by landslide.

Most of the landslides at Farnham Forest were not related to logging-road construction, but were initiated in upper-slope or mid-slope gully depressions generally on slopes over 30°. Similarly, the landslide that inundated the weir at catchment 2 and many of those that damaged baches in Blackwood Bay also originated in upper-slope gully depressions. The landslide material generally becomes concentrated in gullies or stream channels and developed into debris flows or avalanches. Around the time of the storm at Farnham Forest the debate about the future of forestry in the Sounds and the likely trade offs between forest development and maritime environmental protection began to escalate. Since that time, there have been only a few harvesting operations in the Sounds and, generally, they have all been carried out with little environmental impact to both on-site and downstream (receiving waters) values. However, almost all operations have employed some aspects of 'non-standard' harvesting or transportation practices. Many of these have included new or modified log-extraction methods for steep slopes. Alternatively, novel transport methods were involved. It seems inevitable that forestry in the Sounds will continue to test the ingenuity of the harvesting contractors and harvest planners. The current wood resource is generally located on steep, inaccessible slopes. As in other parts of the country, recreational and environmental sectors appear to be placing continued pressure on the Marlborough District Council to ensure that forestry development is not only sustainable but that any environmental effects are minimised.

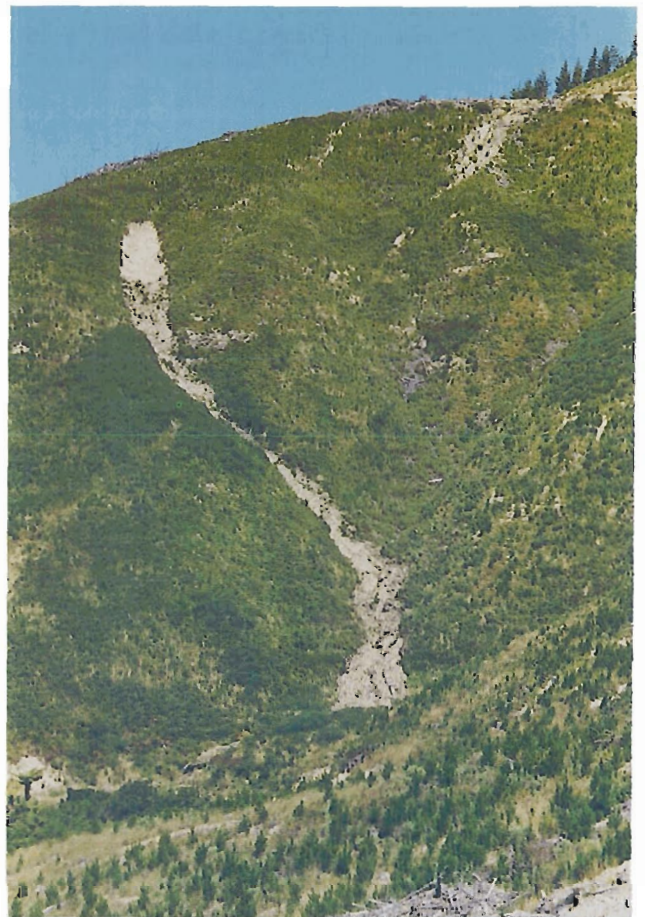
Figure 3. (b) Shallow landslide originating in steep gully head-wall depression which turned into a debris avalanche/flow and destroyed the weir in catchment 2.

tudes below 200 m the soils are moderately to strongly weathered, which makes them more susceptible to failure than less weathered soils at higher elevations (e.g., Laffan, 1987; McQueen *et al.*, 1985; Laffan *et al.*, 1985). The most significant effect of the storm was the landslide which inundated the weir at Rahotia catchment 2 (Figure 3b, c). This landslide occurred around 5.40 pm on the evening of November 7 and coincided with the period of highest rainfall intensities of the storm (9 mm between 5.30 pm and 5.45 pm) (Figure 4).

A number of small landslides occurred in various parts of the cutover, but generally these were small shallow failures in which the failed material remained close to the point of failure. Several landslides, including the one which damaged the weir, became channelised and turned into debris avalanche-flows which in turn eroded material from ephemeral stream or swale areas. Since the major streams at Rahotia cross a wide fan before entering the sea, slopes are not directly coupled to the marine environment. This change of gradient assists the 'capture' and retention of sediment on site. Unfortunately, other parts of the Sounds do not have the benefits of these flatter areas and the streams and slopes grade directly to the sea. In these cases, any sediment entering the waterways from roads or landslides is flushed directly into the sea.

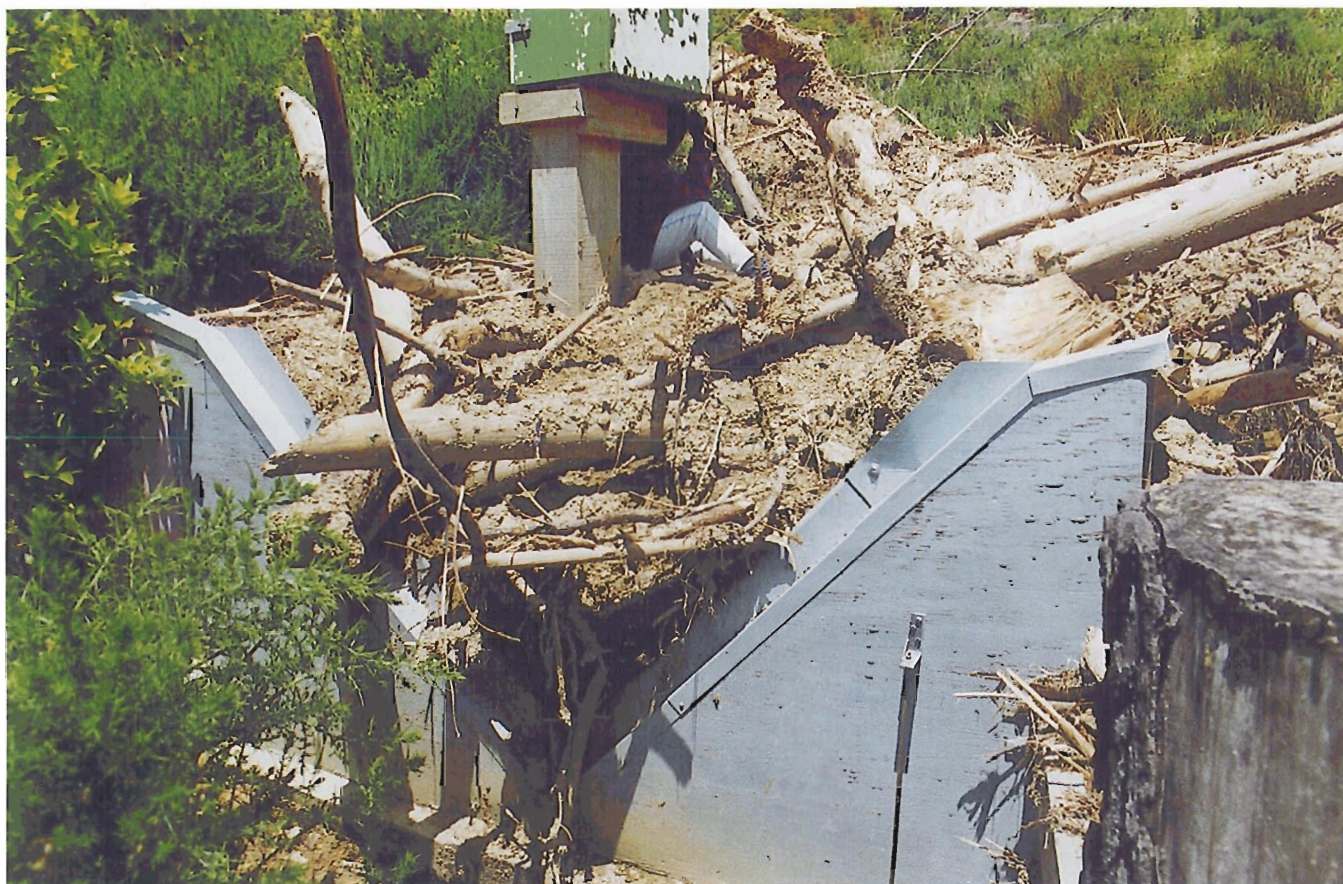
Figure 3. (c) Catchment 2 weir filled with landslide debris.

Apart from the stream draining catchment 2 whose weir was affected by the debris flow, the stream channels draining the
