After the storms

A case study in risk reduction

“Report on exotic forest debris management related to storm events in the Bay of Plenty”

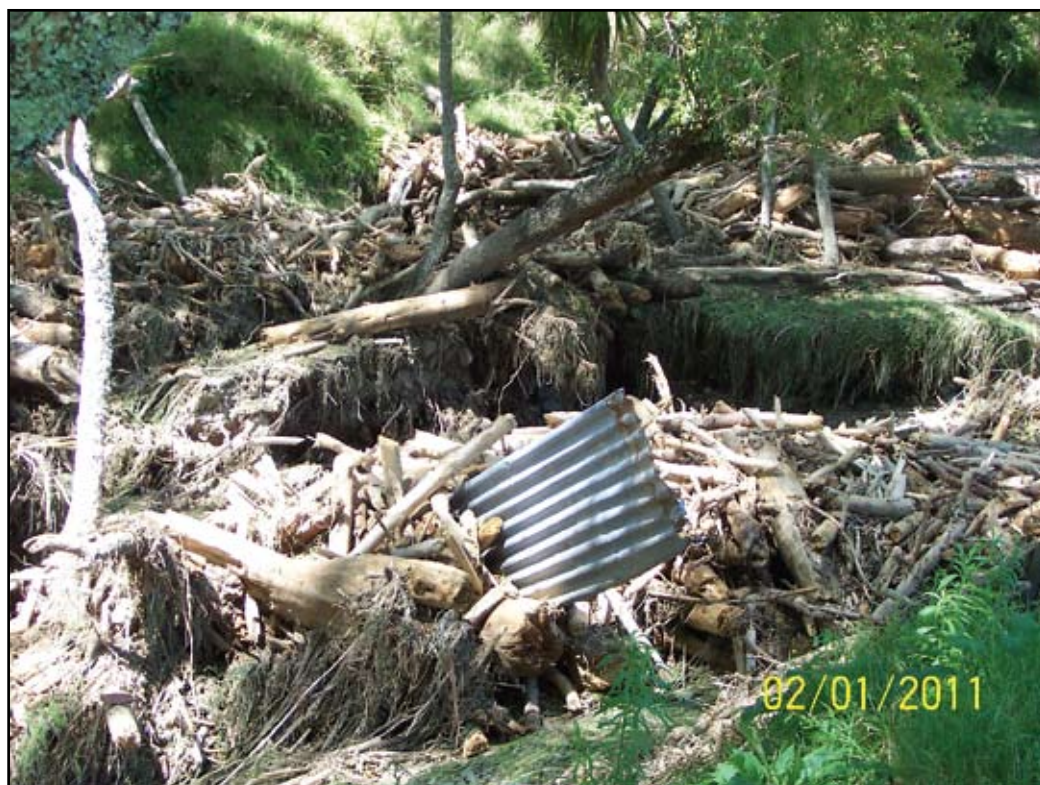
*Woody debris becomes lodged in mid-catchment.
(Photo courtesy Bay of Plenty Regional Council)*

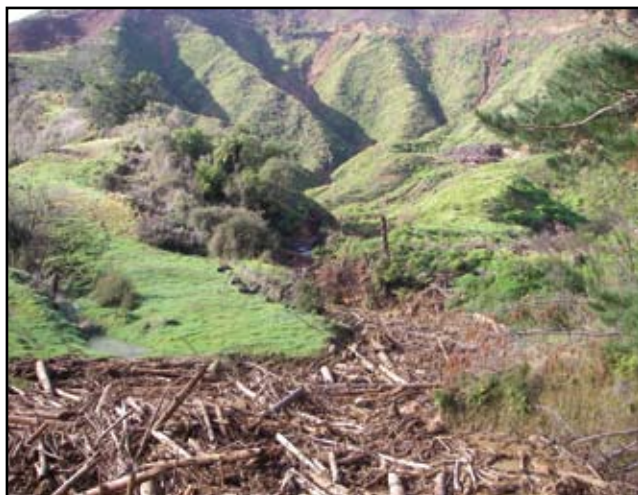
Logging debris washed down from steep slopes into flowing waterways. (Photo courtesy Bay of Plenty Regional Council)

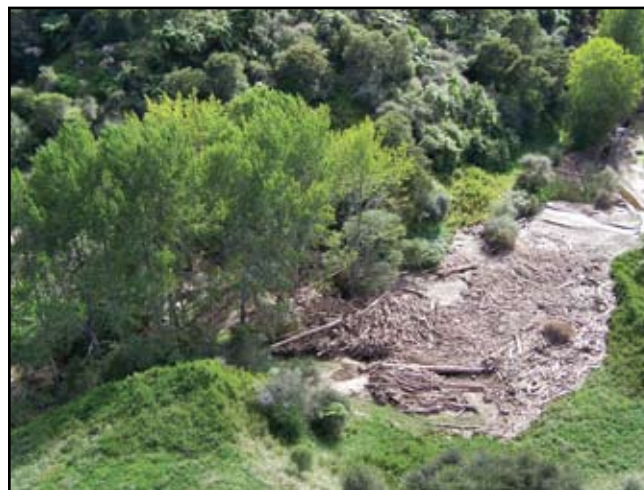
Significant erosion which carried logging slash down-stream. (Photo courtesy Bay of Plenty Regional Council)
